PASSENGERS' PERCEPTIONS OF MANCHESTER'S STATIONS

Oxford Road Station

February 2009

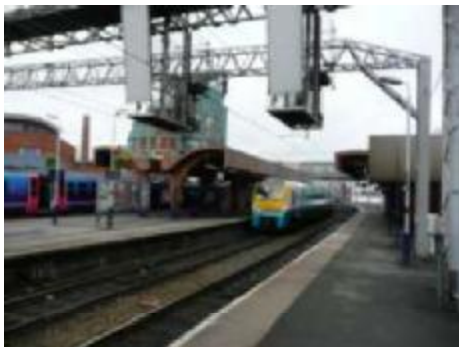
- g) There is no provision of disabled toilets.
- h) The only access to Platforms 3/2 and 1 is by means of the stepped footbridge which proves to be a real obstacle to passengers with heavy luggage, young families or those who are mobility impaired. There are lifts at the eastern end of the station but these seem to permanently out of use. In any case there is no lift access to Platform 1. For a station of this size and importance the lack of disabled access is unacceptable.

The regularly used outer platforms can only be accessed by the overbridge.

- i) The relatively narrow footbridge becomes crowded at peak times, with no indication of flow control.
- j) The significant difficulty in reaching the outlying platforms is unacceptable for a heavily used station in a forward looking city.

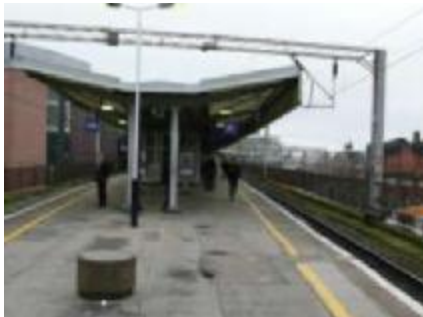
- d) Platforms 13 and 14 can therefore become very crowded at certain times. Although the platforms are very long and could each hold two trains, the practicality of determining which end of each platform will be used previously caused more delay (by passengers often being in the wrong place) than allowing one train onto each platform. Thus potentially important platform faces remain unused.

Although empty in the early afternoon, these platforms can become seriously crowded.

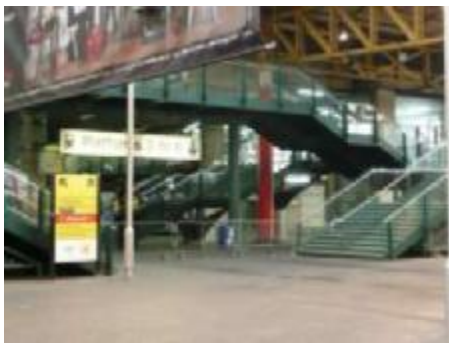
- g) As a result of the placing of 'temporary' barriers (to aid ticket checking) the large sign indicating the direction to Platforms 4 – 6 is now incorrectly sited. This again can lead to uncertainty among non-regular users.

**The misleading access signs
for the outlying platforms.**

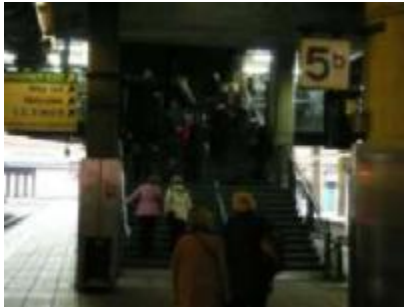
- i) It would make good sense to have a directional flow on the stairs, as is the case at York, to prevent conflicting movement at busy times.
- j) The areas surrounding the stairs leading to Platforms 4/5 and 6 are very dark and potentially dangerous. It is surprising that a risk assessment has not highlighted the need for a marked improvement in lighting level in these areas.

The dark route from the platforms to the overbridge.

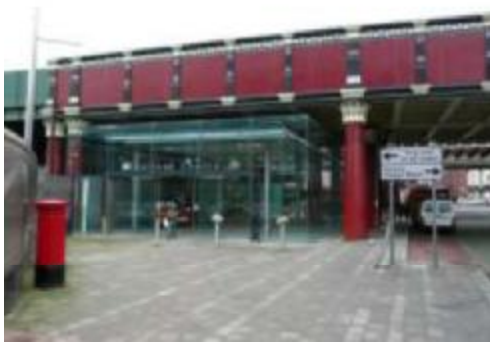
- 1 The newly constructed entrance.
- 2 Very low platform.
- 3 The cordoned-off flooded underpass.

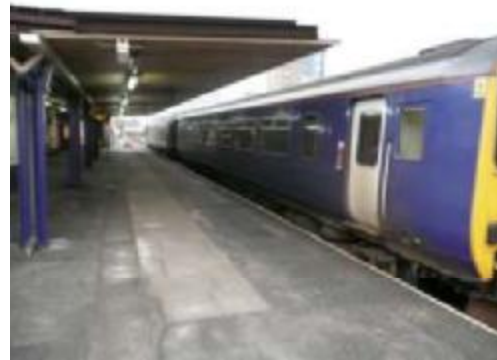
2

6.1 This one-time peak-only station has experienced a new lease of life as a result of the surrounding office development. It has received a worthwhile make-over in recent months and is now much more welcoming. It is unfortunate that even after this major re-build the underpass still floods after heavy rain. The platforms are now fully accessible via either ramps or lifts but they are very low, requiring a high step onto trains. Conductors on trains calling at the station are required to advise alighting passengers of the very low platforms.
